Emerald Coast Utilities Authority

**Consulting Engineering and Bond Feasibility
Report for Water and Wastewater System**

December 2010

Malcolm Pirnie, Inc.

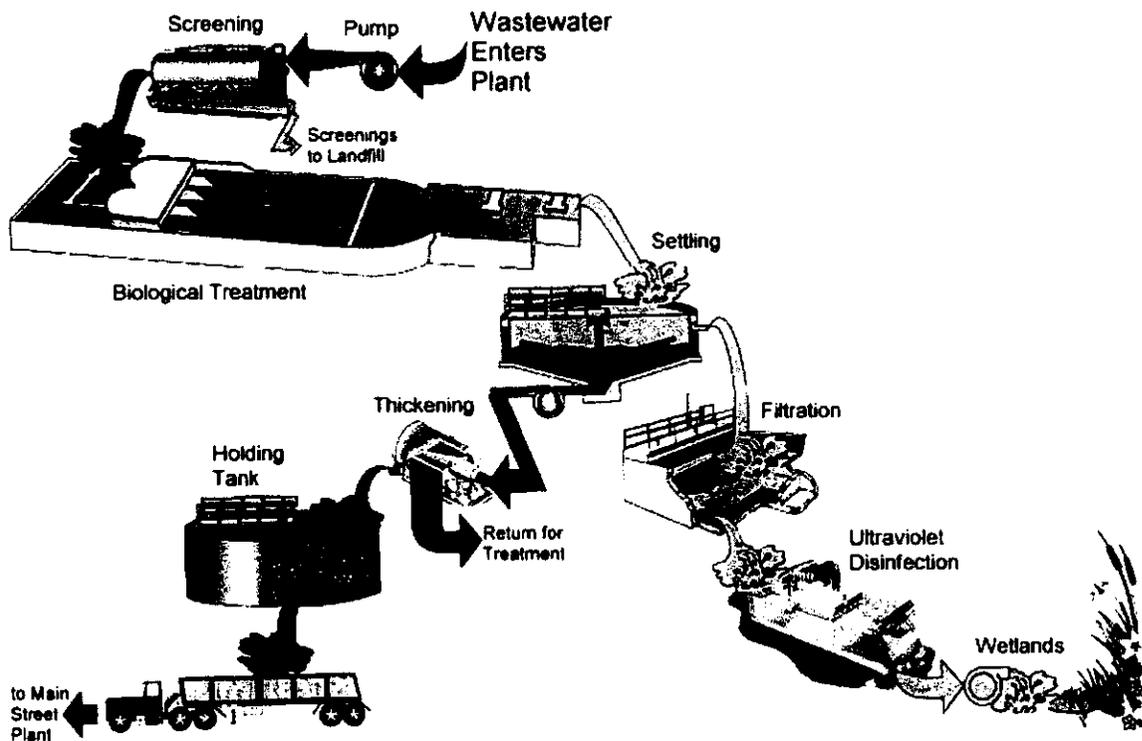
Figure 3-2.
Bayou Marcus WRF Treatment Process Diagram

- Wastewater Pumps
- Screens
- Biological Treatment Unit
- Clarifiers
- Filtration Unit
- Ultra Violet Disinfection Unit
- Discharge to wetlands

Figure 3-2 below depicts a flow diagram of the Bayou Marcus WRF.
